Triage Report (Part 2)

Hurricane Ian of 28 September 2022

Recommended Study of its Impacts on Residential Structures

Sponsor: Florida Building Commission
6 December 2022

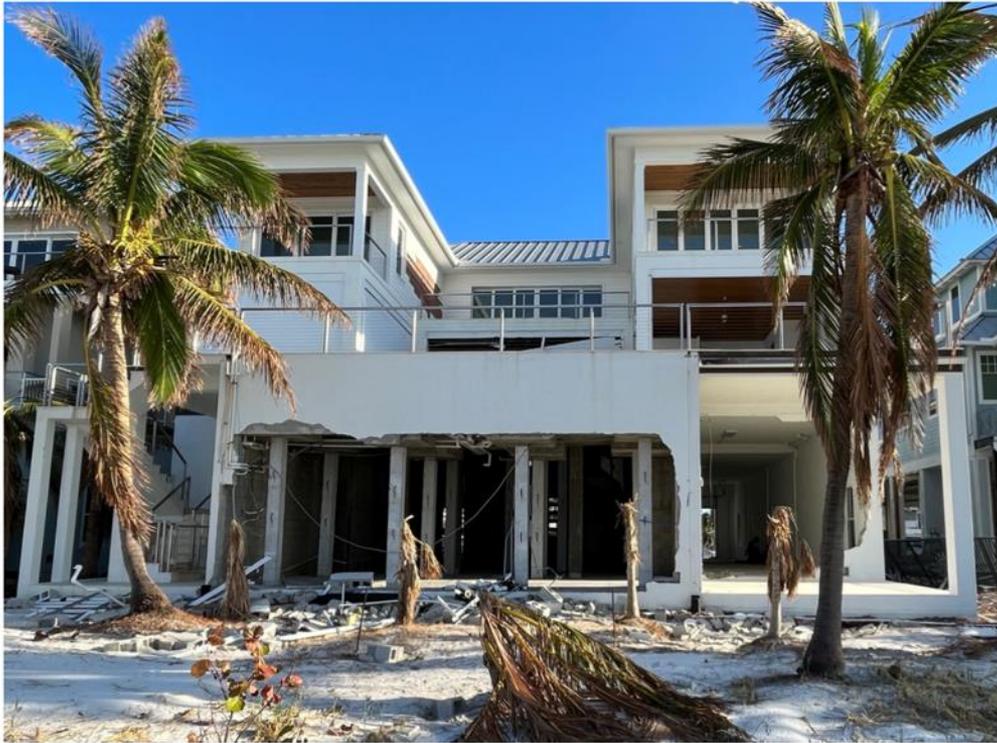
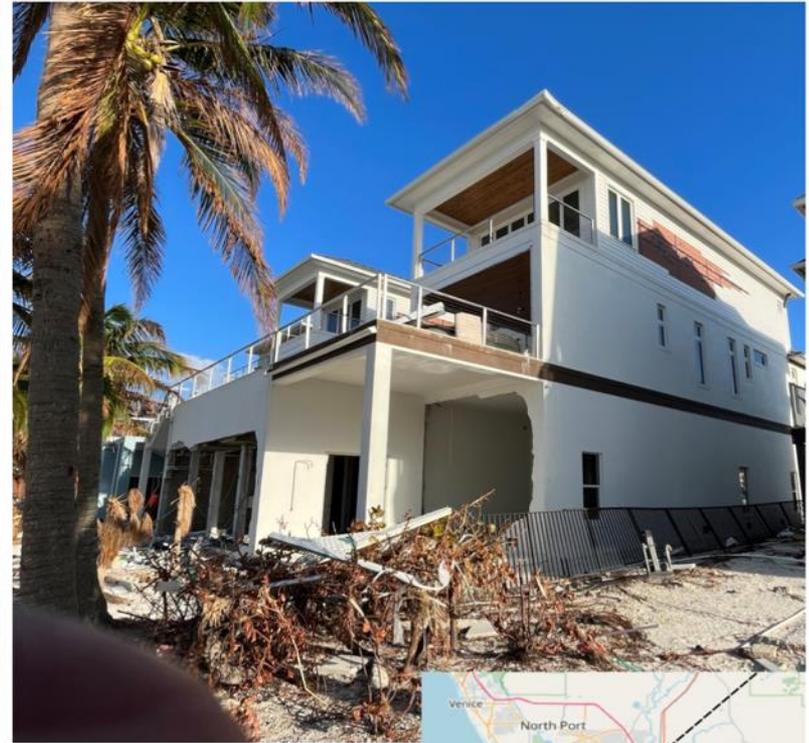
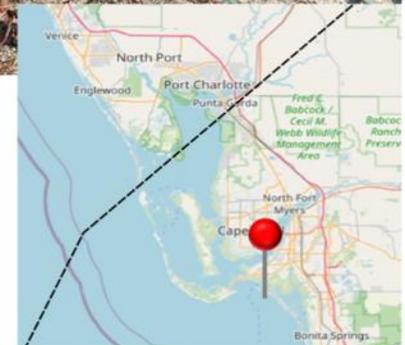
Location:	Seaward of CCCL; Estero Blvd and Washington Ave., Ft. Myers Beach, FL	Year Built:	2018
Wind Speeds:	~100 mph gusts	Storm Surge:	~16 ft relative to NAVD88, ~11 ft relative to ground
Comments:	Photos looking inland from beach side; breakaway walls performed as intended. Minor wall cladding loss. No visible damage to metal roof.

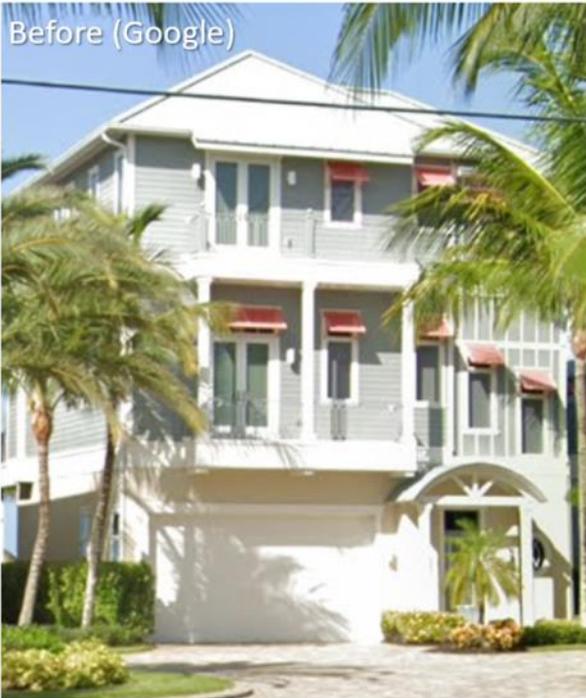
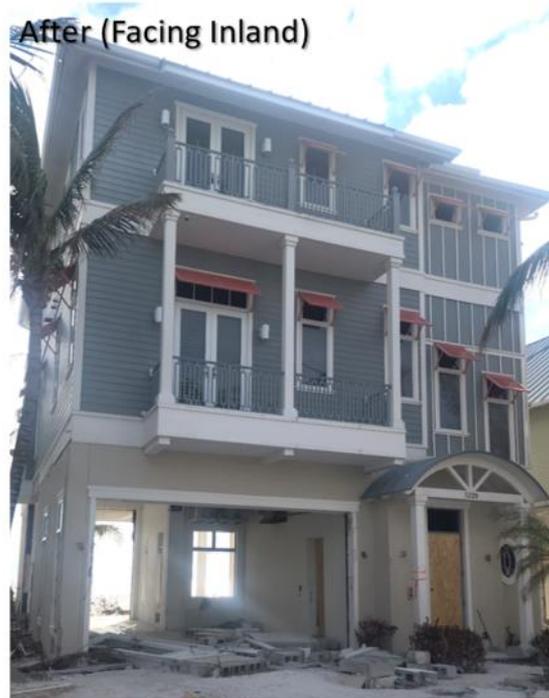
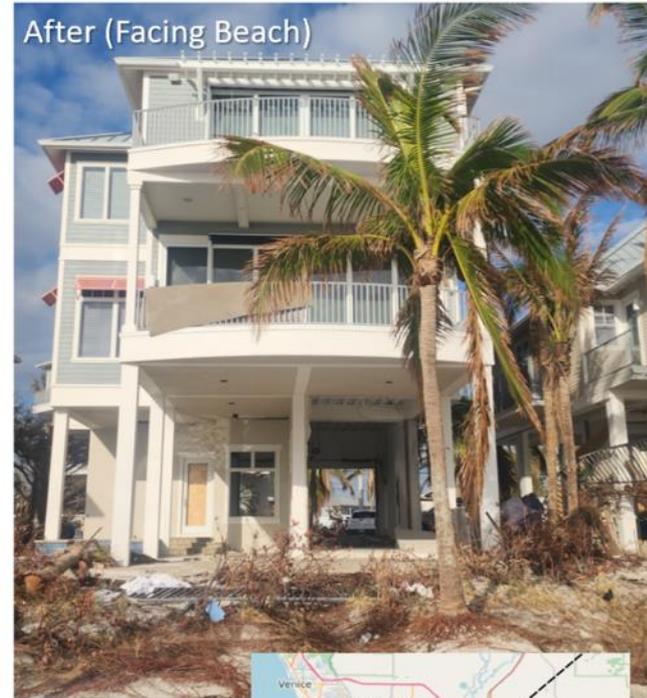
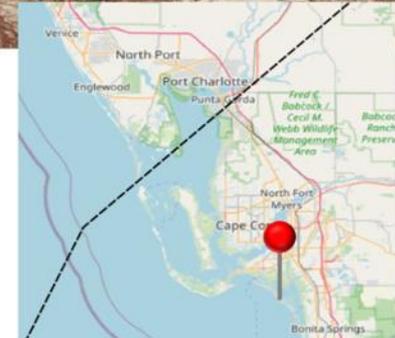
Location:	Seaward of CCCL, Estero Blvd and Avenida Pescadora, Ft. Myers Beach, FL	Year Built:	2015
Wind Speeds:	~100 mph gusts	Storm Surge:	~19 ft relative to NAVD88, ~13 ft relative to ground
Comments:	Breakaway walls performed as intended. No visible damage to metal roof or wall cladding in occupied stories.

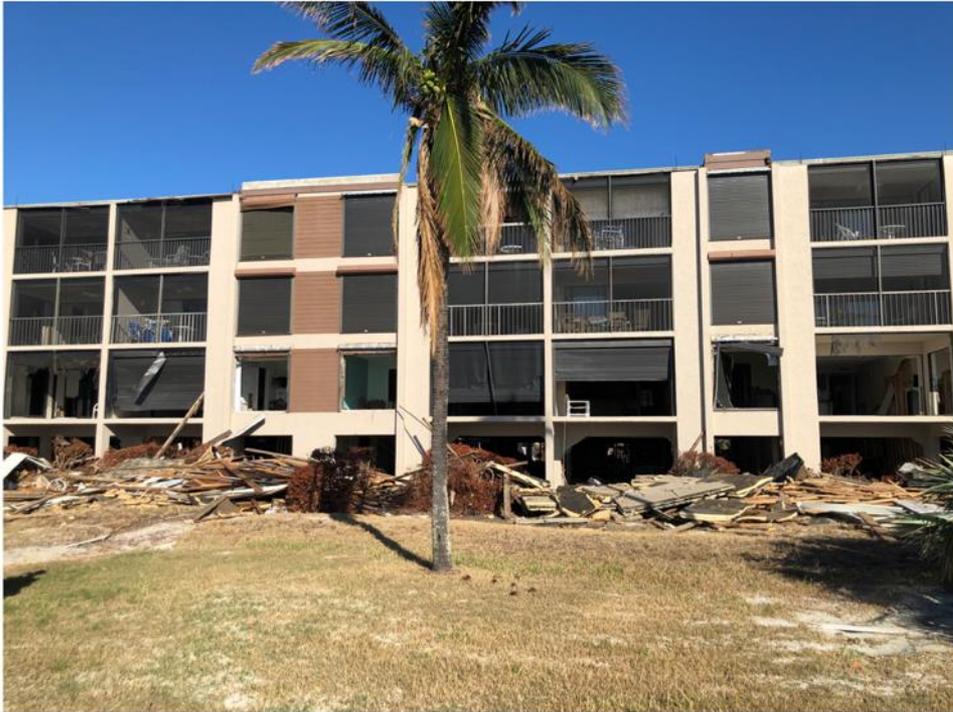
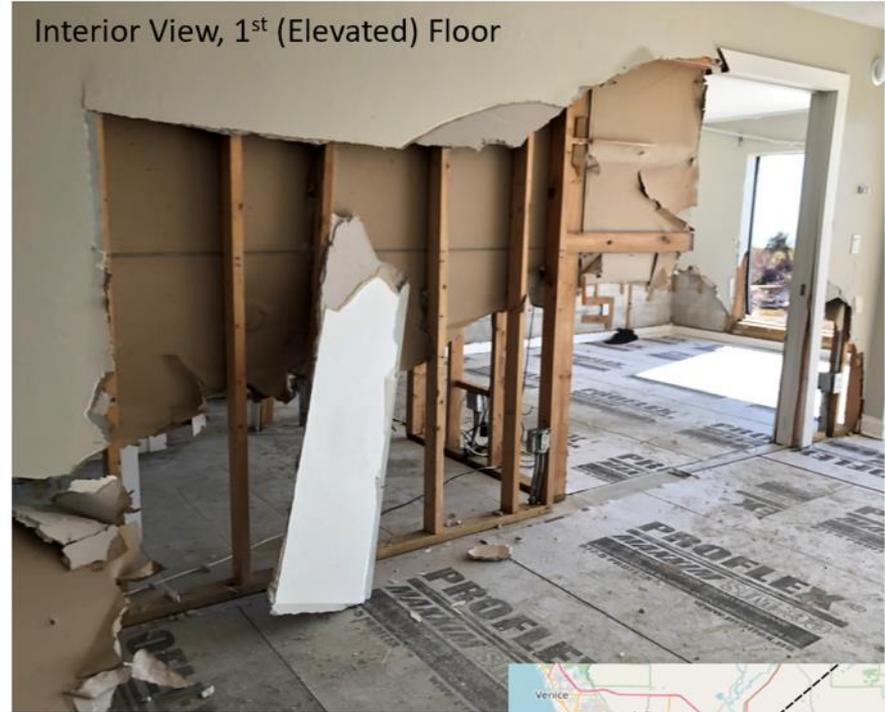
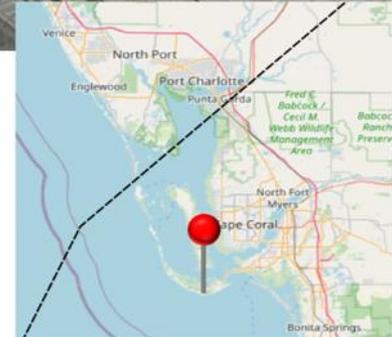
Location:	Donax St, Sanibel Island, FL.	Year Built:	1978
Wind Speeds:	~110 mph gusts	Storm Surge:	16.5 ft relative to NAVD88 ~12 ft relative to ground
Comments:	Some roof cover damage, exterior cladding damage. Heavy interior damage in 1 st (elevated) floor due to storm surge.

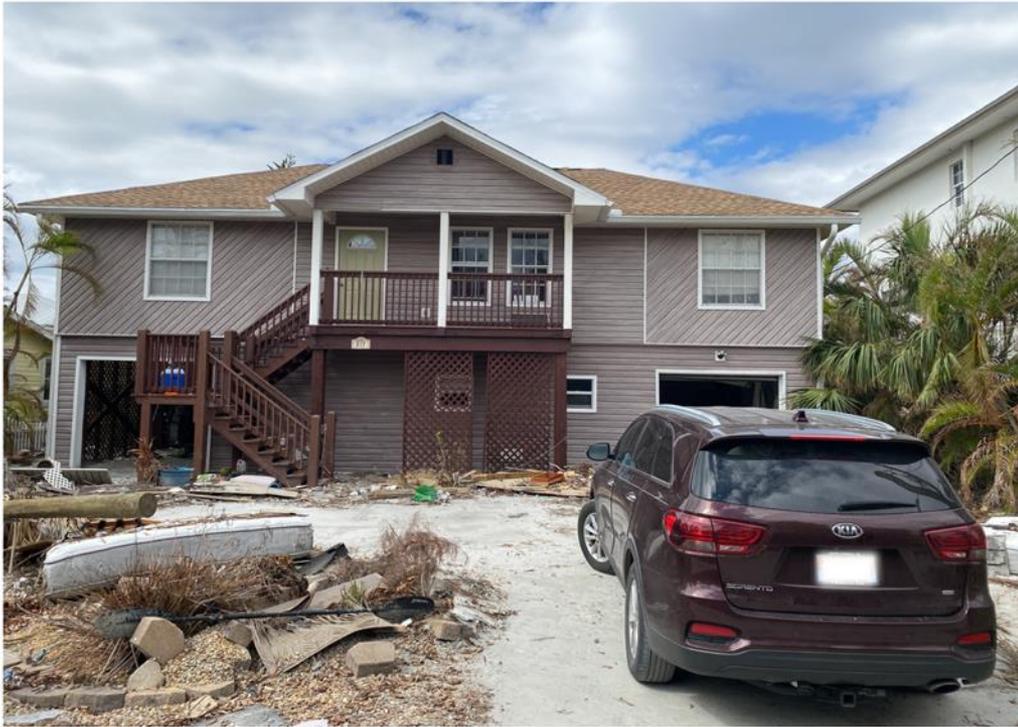
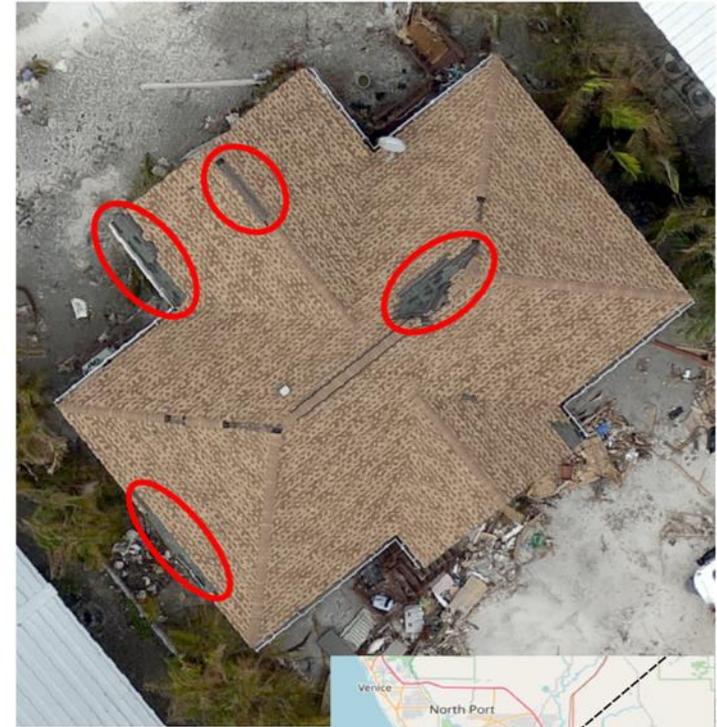
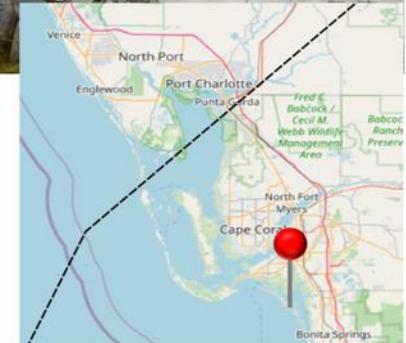
Location:	Driftwood Ln, Ft. Myers Beach, FL. ~0.3 miles from Gulf Coast.	Year Built:	1996
Wind Speeds:	~100 mph gusts	Storm Surge:	~14 ft relative to NAVD88, ~9 ft relative to ground
Comments:	Structure performed well; some loss of asphalt shingles; no other visible signs of exterior damage. Roof replaced in 2017 following Hurricane Irma.

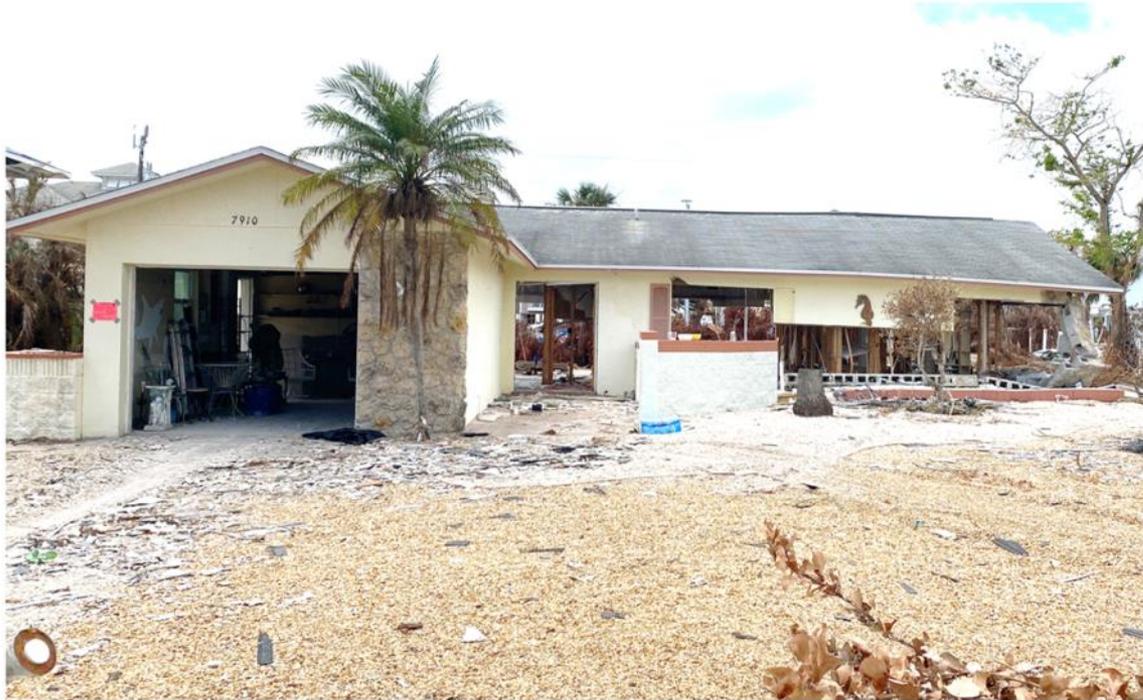
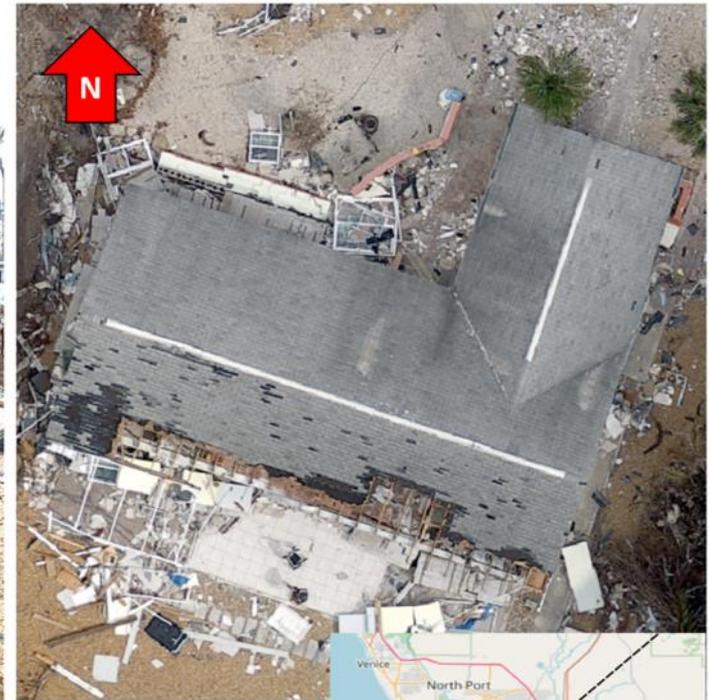
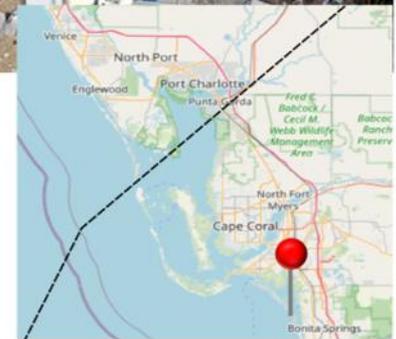
Location:	Buccaneer Dr, Ft. Myers Beach, FL. ~0.18 miles from Gulf Coast.	Year Built:	1974
Wind Speeds:	~100 mph gusts	Storm Surge:	~16 ft relative to NAVD88, ~10 ft relative to ground
Comments:	Partial loss of exterior walls due to storm surge flow-through. Partial loss of asphalt shingle roof that was installed in 2006.

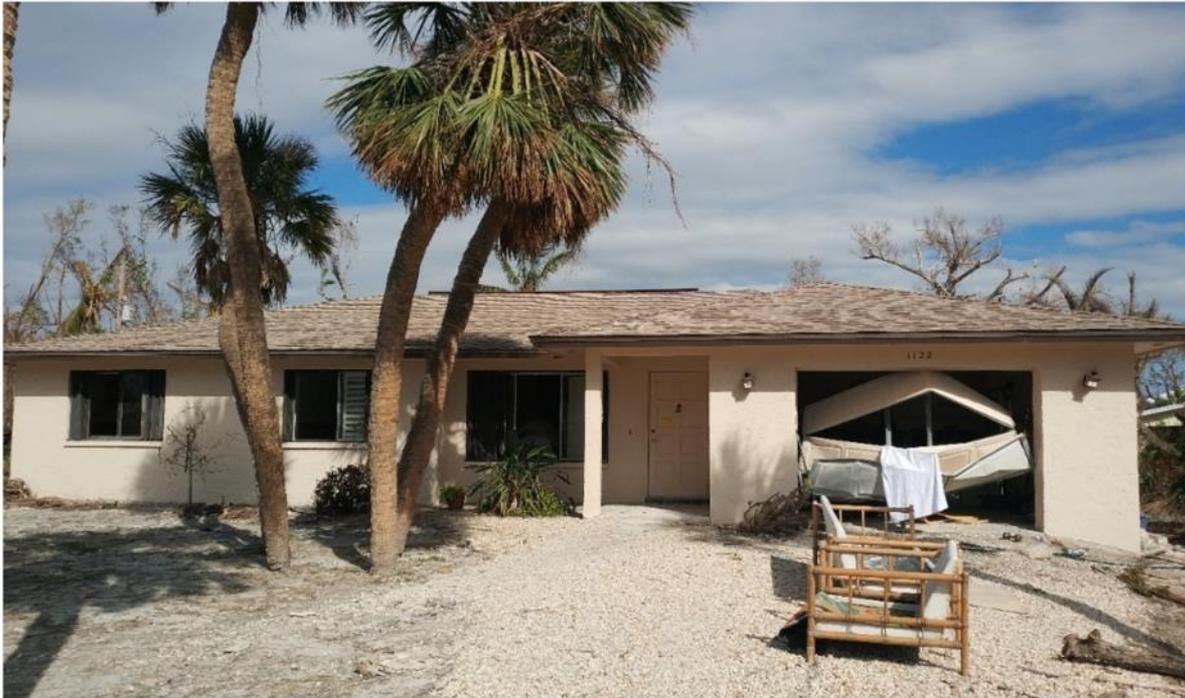
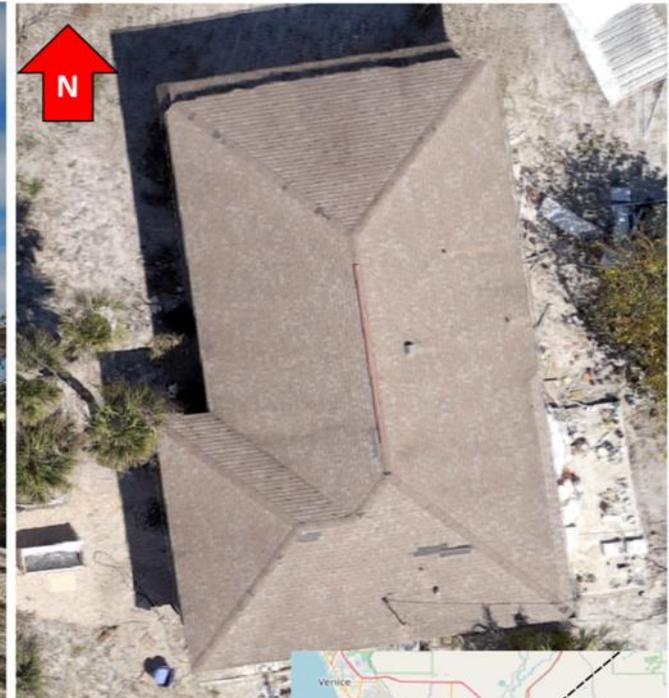
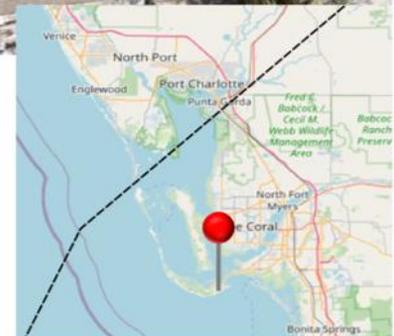
Location:	Buttonwood Ln, Sanibel, FL. ~0.15 miles from Gulf Coast.	Year Built:	1976
Wind Speeds:	~110 mph gusts	Storm Surge:	~11 ft relative to NAVD88, ~8 ft relative to ground
Comments:	Blow out of garage door; minor roof cover loss. No other visible signs of exterior damage.

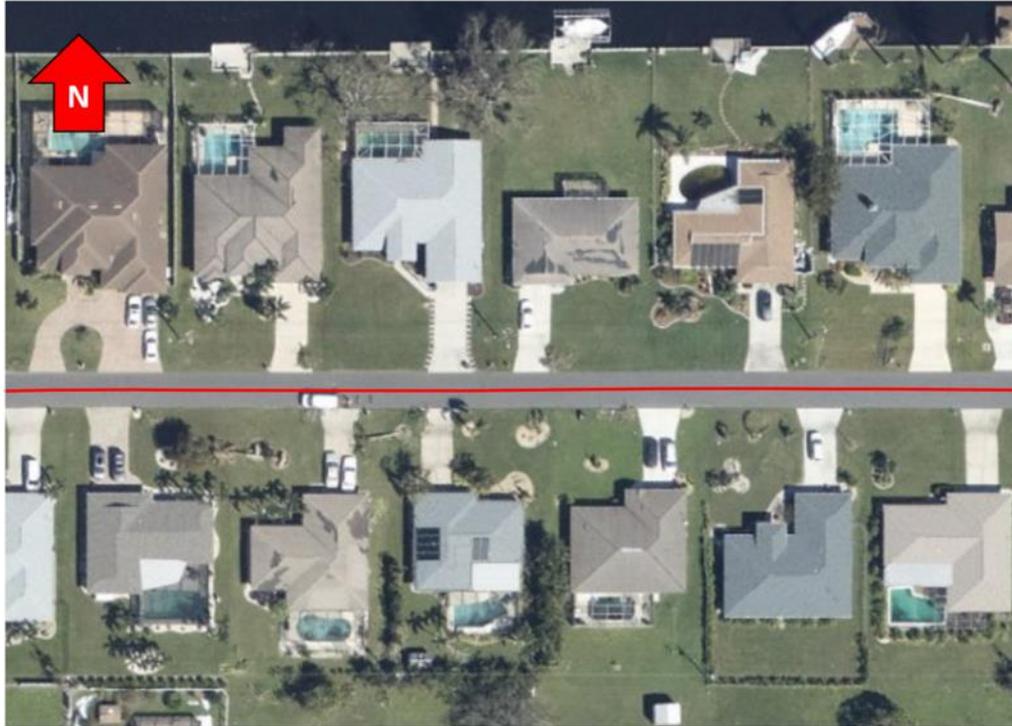
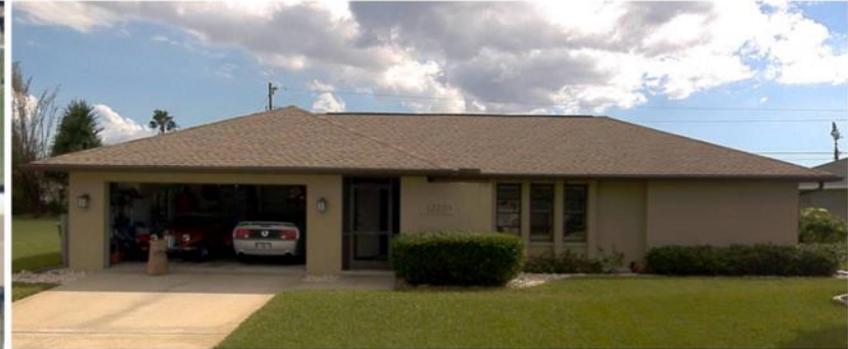
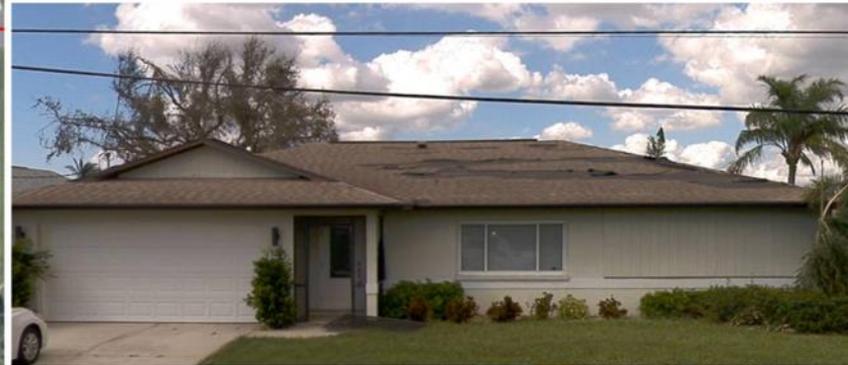
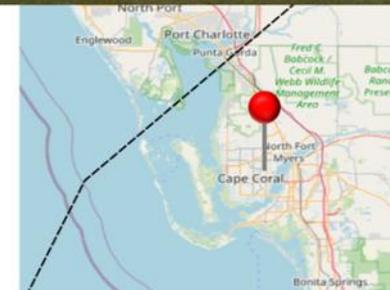
Location:	SE 17 th St, Cape Coral, FL.	Year Built:	Mix of mostly 1980s and 1990s
Wind Speeds:	~105 mph gusts	Storm Surge:	N/A
Comments:	Isolated roof cover loss; generally no other signs of visible exterior damage.

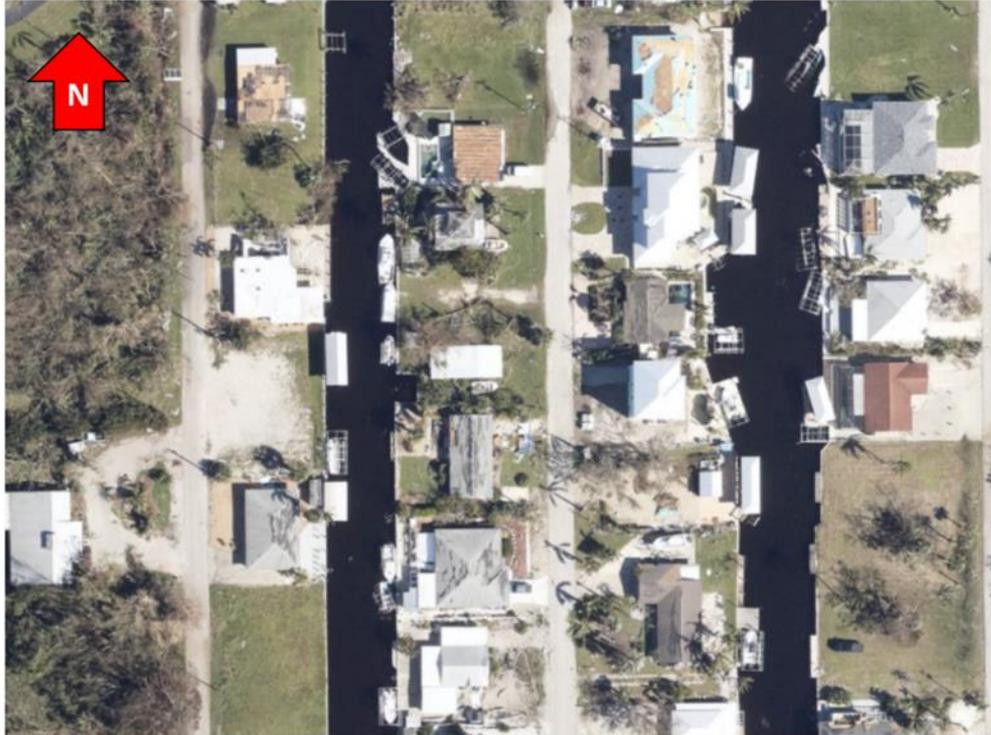
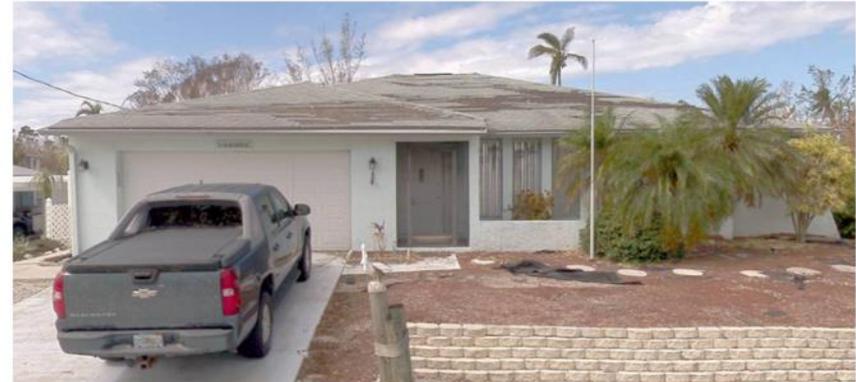
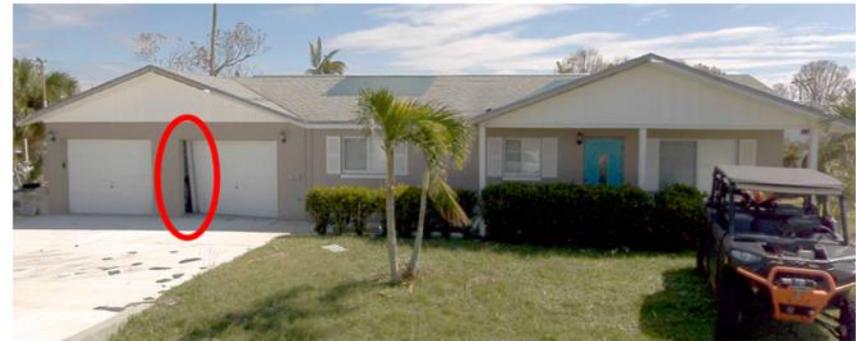
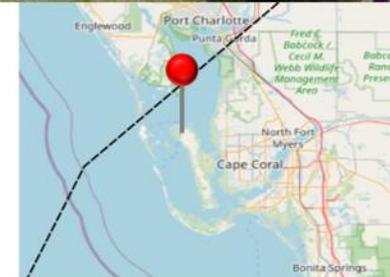
Location:	Porto Bello St, Pine Island, FL.	Year Built:	Mostly pre-FBC construction
Wind Speeds:	~120 mph gusts	Storm Surge:	N/A
Comments:	Frequent roof cover loss; isolated cladding and fenestration damage; isolated damage to attached porches.

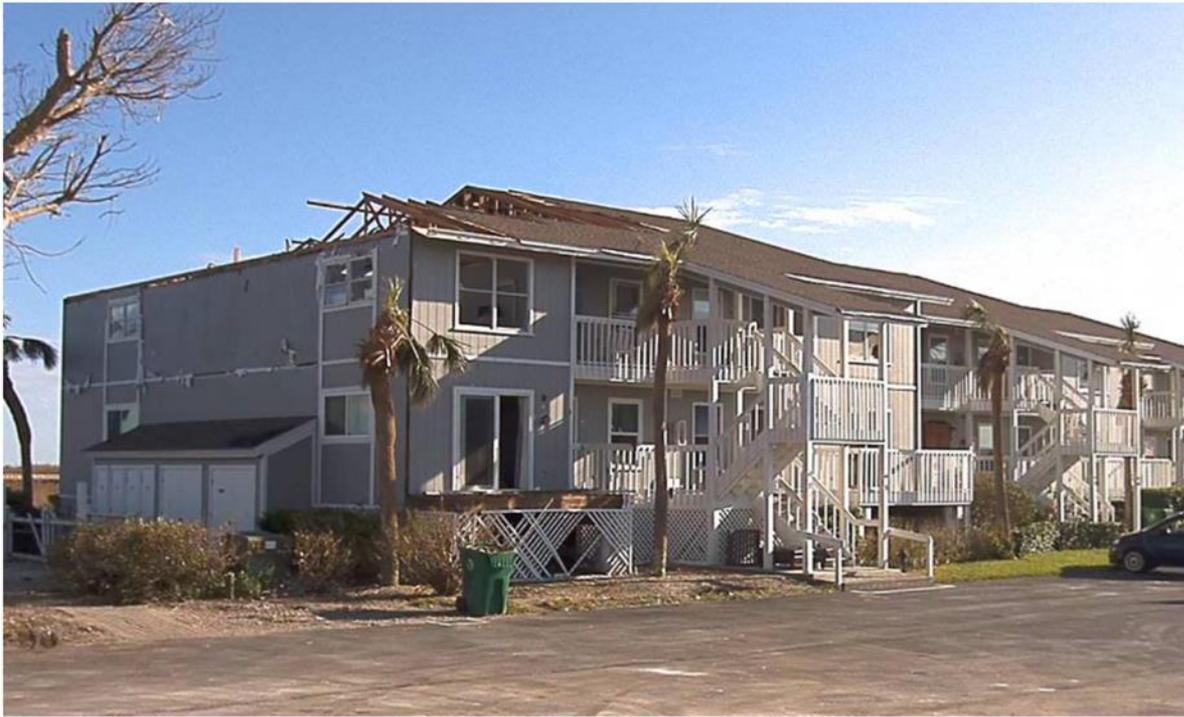
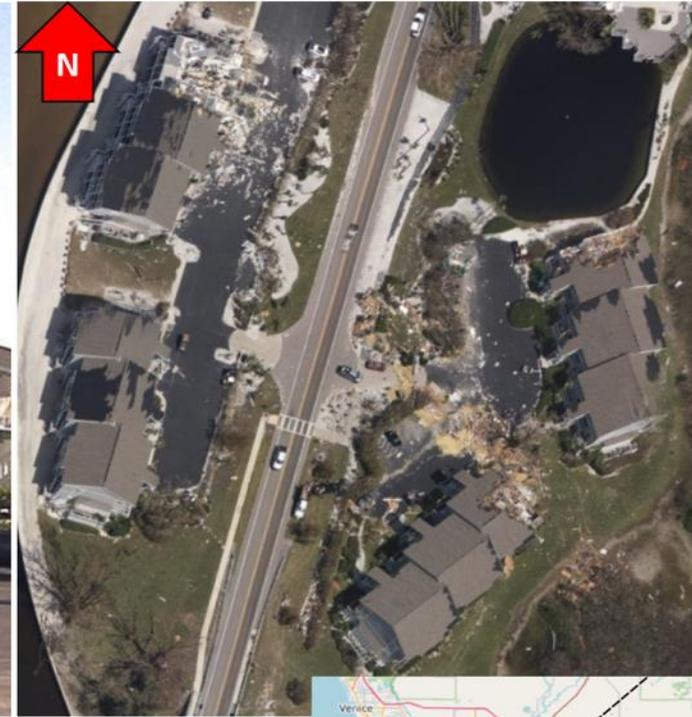
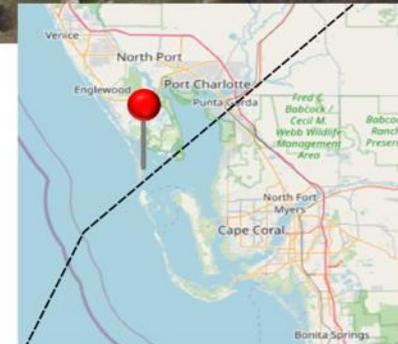
Location:	Boca Grande Causeway, Boca Grande, FL.	Year Built:	1980s
Wind Speeds:	~120 mph gusts	Storm Surge:	Unknown
Comments:	Collapse of gable ends in multiple multi-family units; loss of asphalt roof shingles.
