Triage Report (Part 2)

Hurricane Ian of 28 September 2022

Recommended Study of its Impacts on Residential Structures

Sponsor: Florida Building Commission
6 December 2022

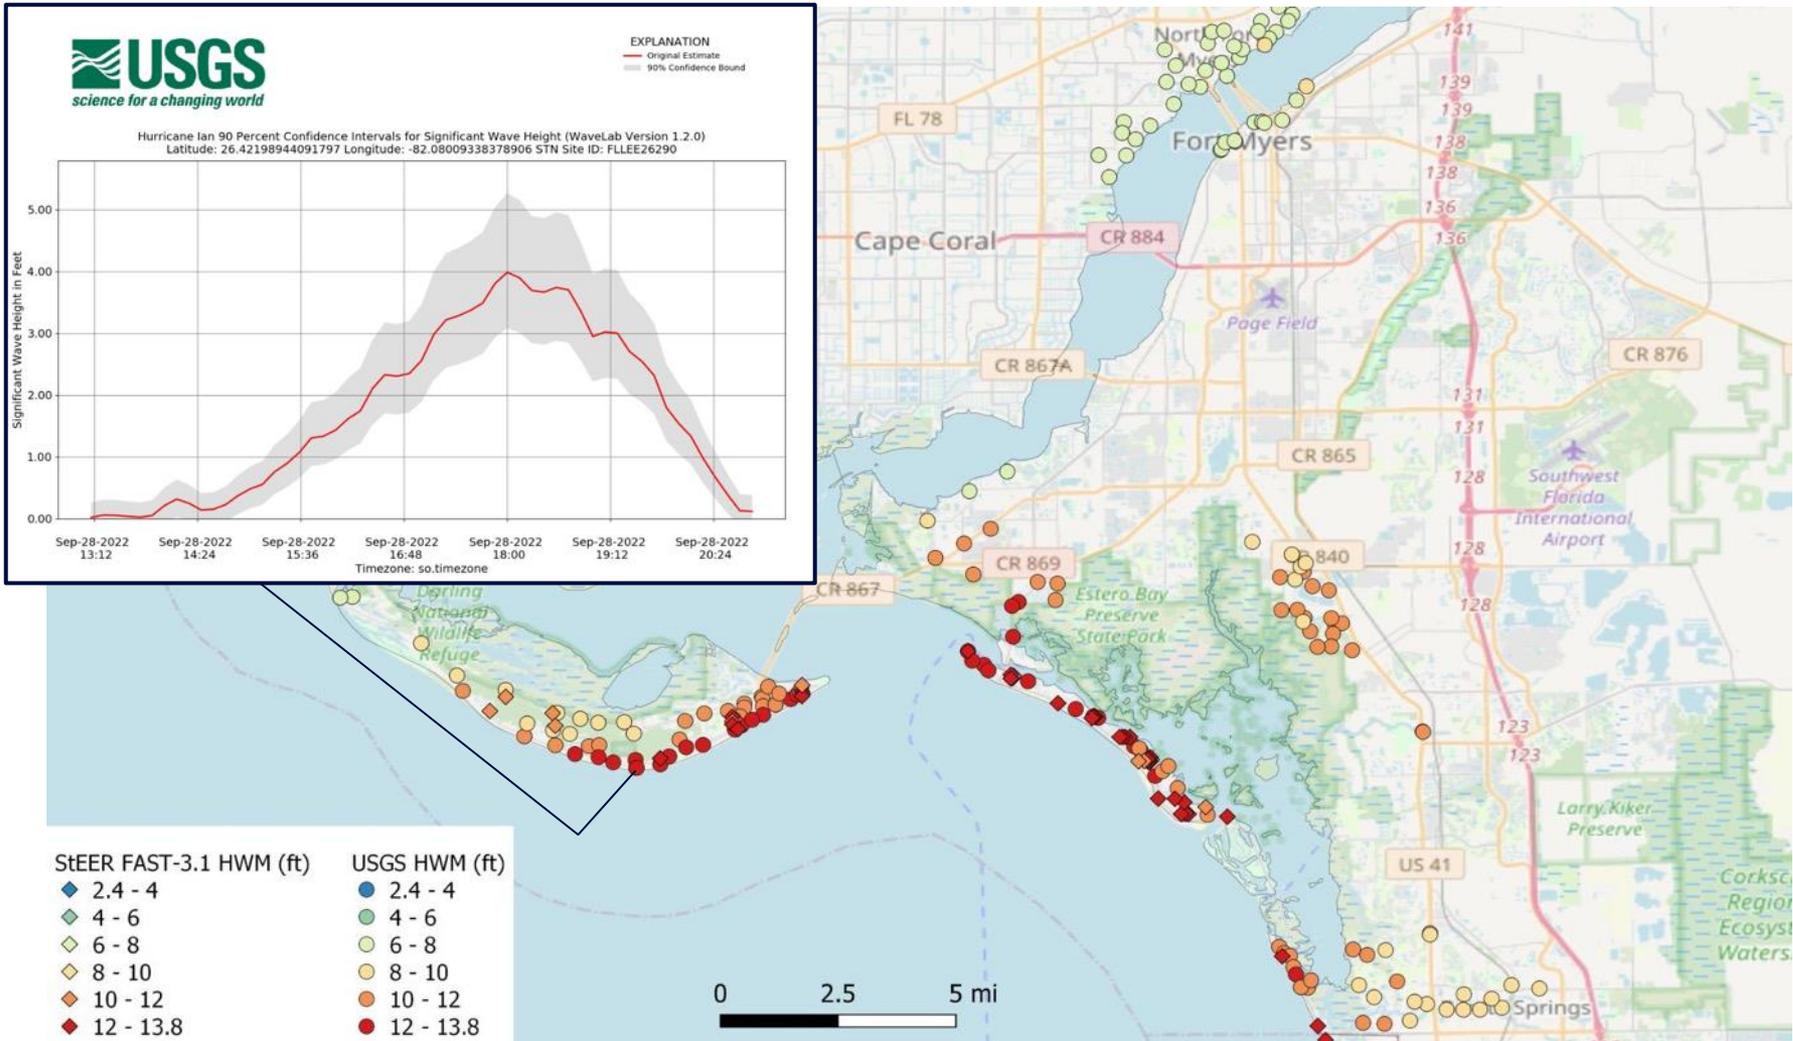
High Water Marks in Lee County

Note: HWM represent still water depths above NAVD88 (~MSL).
 StEER FAST-3.1 HWM collected and processed by Pat Lynett, University of Southern California

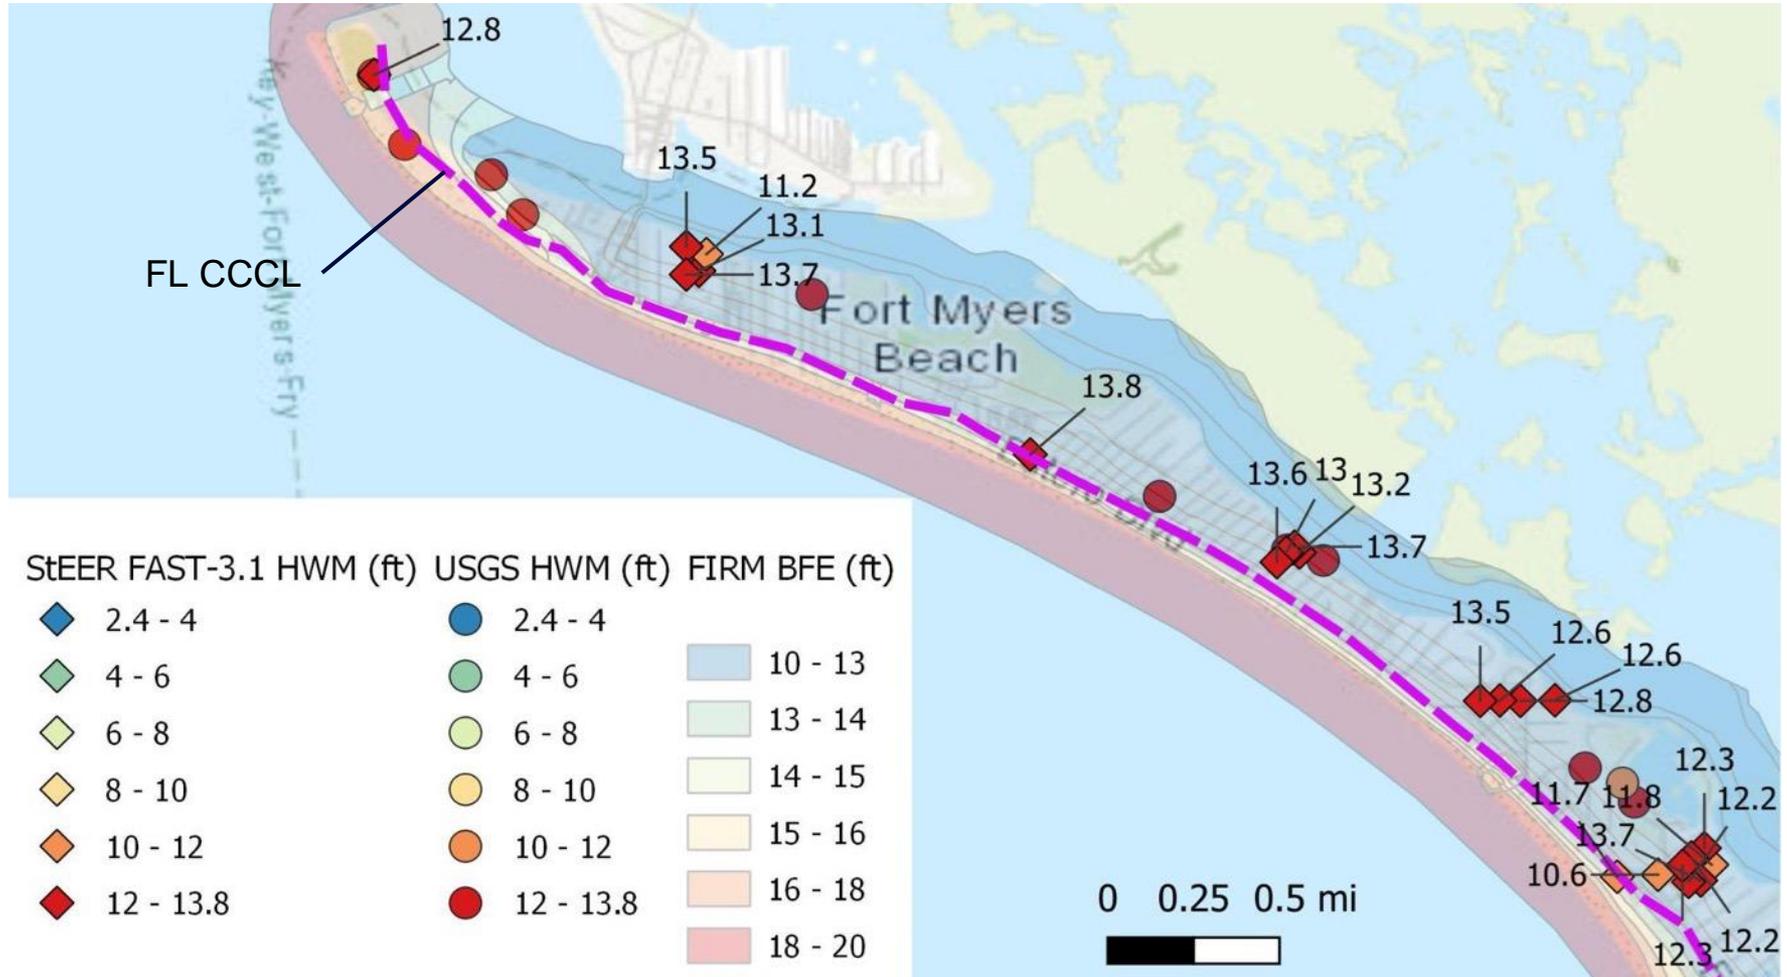
HWM Relative to BFE in Ft. Myers Beach

Note: HWM and FIRM BFE relative to NAVD88

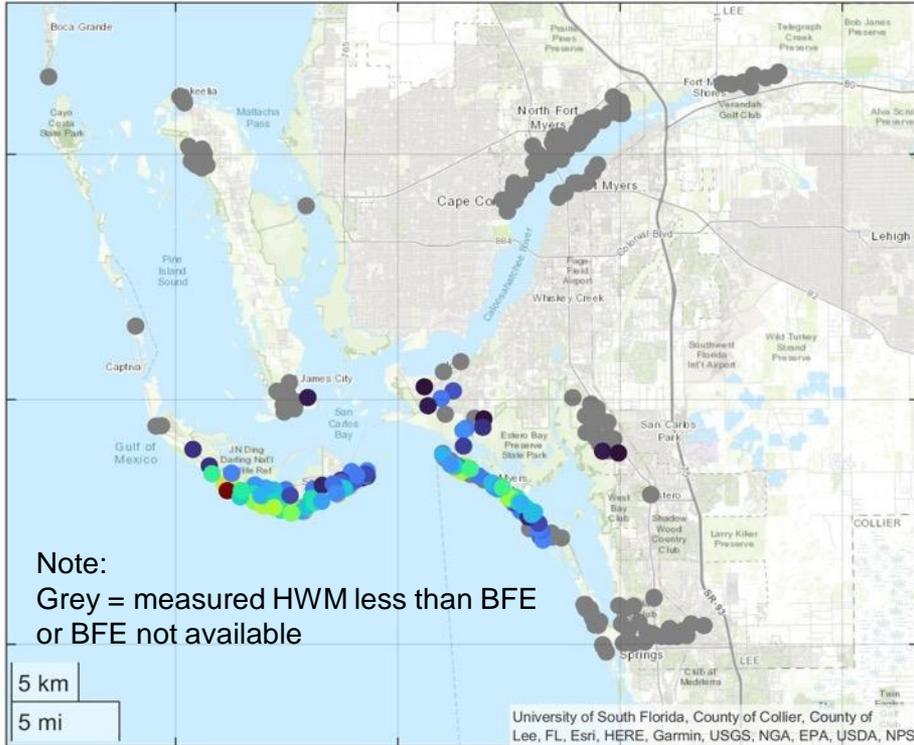
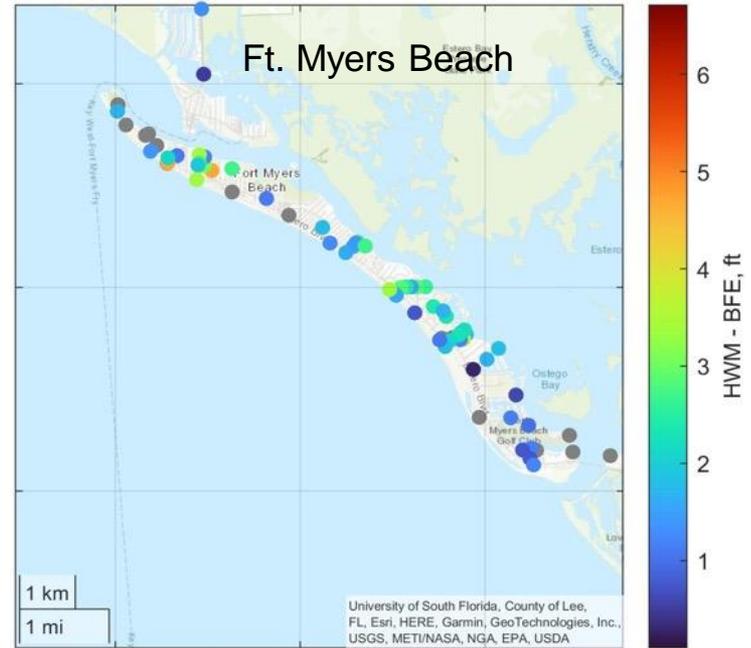
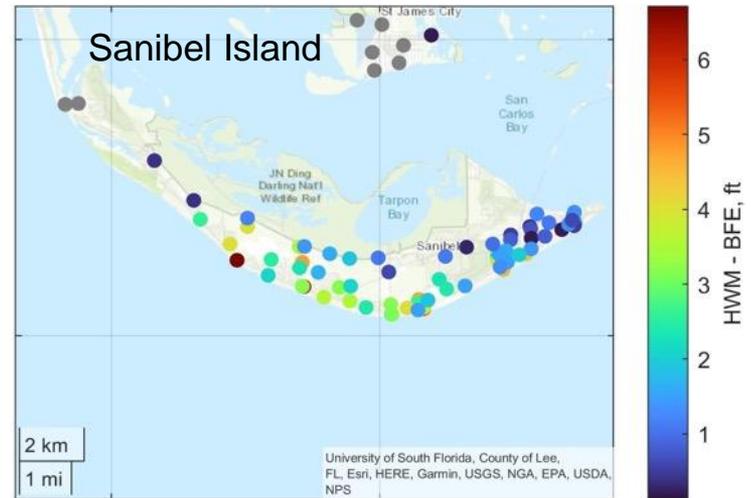
HWM in relation to BFE

Note:
 Grey = measured HWM less than BFE
 or BFE not available

Colored circles provide height by which measured high water marks **exceeded** the current Base Flood Elevation.

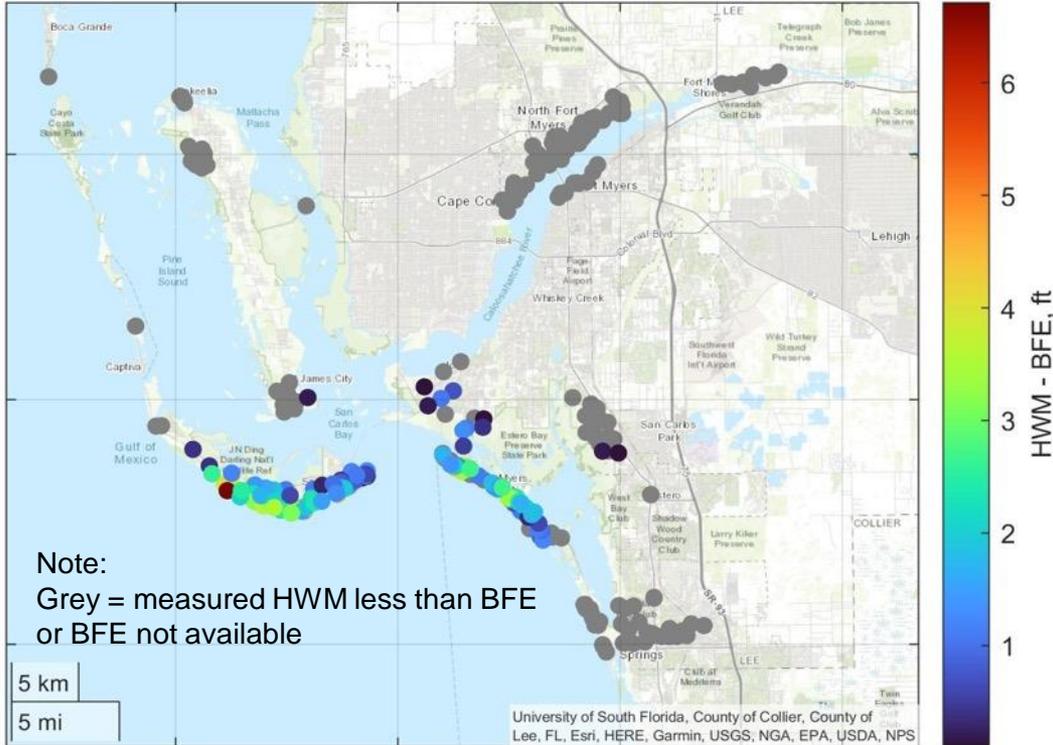
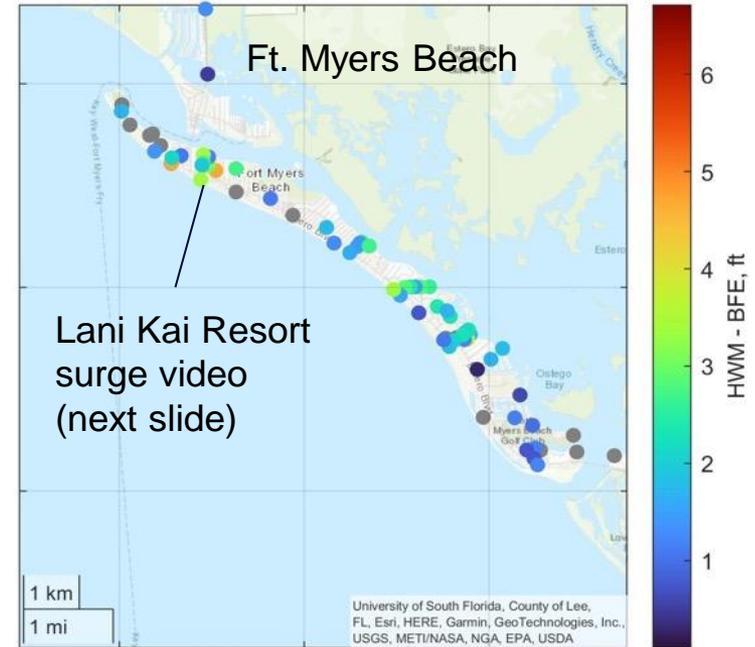
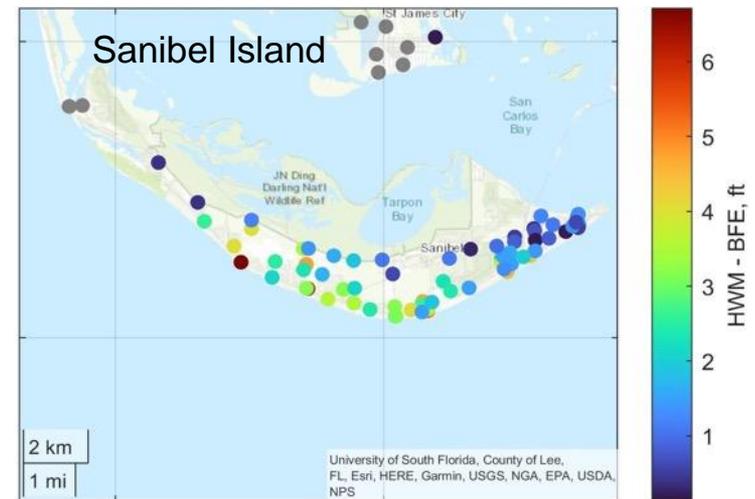
HWM in relation to BFE

Colored circles provide height by which measured high water marks **exceeded** the current Base Flood Elevation.
